Risks associated with nearshore instability Inskip Point, Qld

Document Reference:
B01006-IAE

Version:
25 November 2015

EDG Consulting Pty Ltd
91 Commercial Road
Teneriffe QLD 4005
t: +61 416 132 343
e: admin.edg@edgconsult.com.au

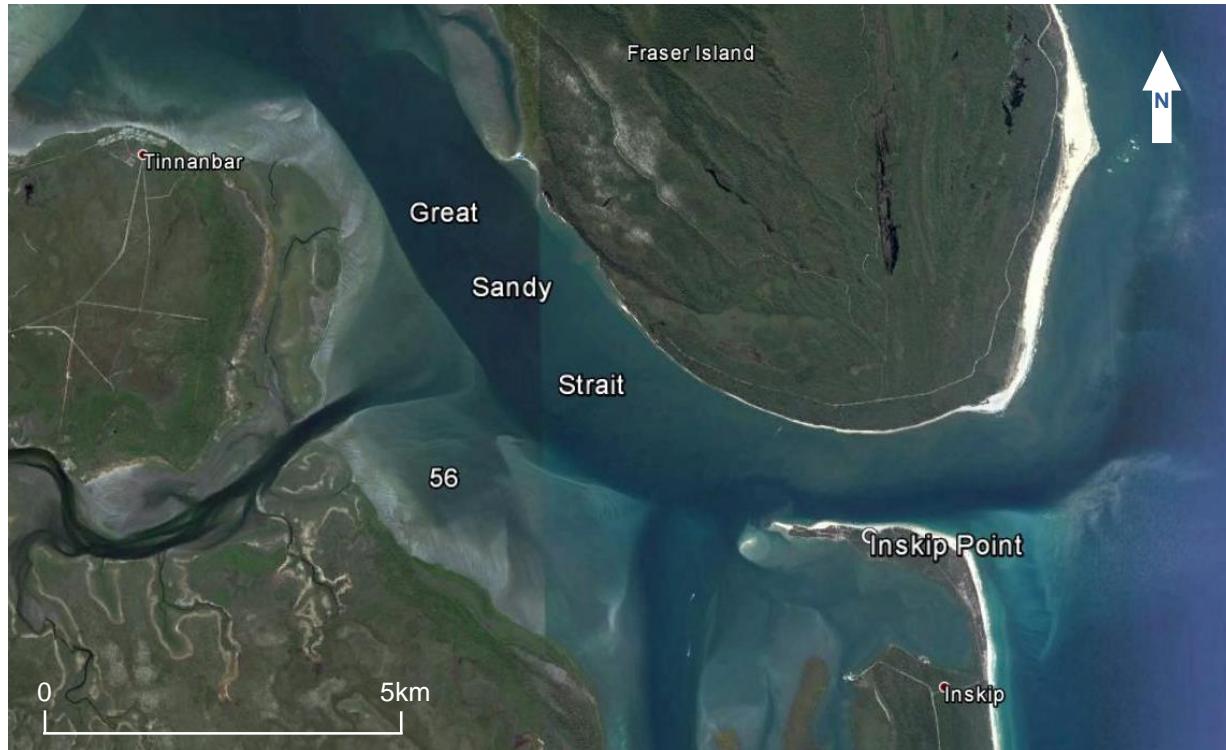
Figure 1.1 Location of Inskip Point (Map Data: Google, Digital Globe, CNES/Astrium 2015)

Inskip Point is a sand peninsula, north of Rainbow beach which forms the southern edge of the channel leading to the Great Sandy Strait (Figure 1.1).

One distinctive feature of the profiles is the relatively steep near-shore slope (slope angle typically 22° to 24°) which falls from around 0 m elevation down to about -7 m elevation. That steep slope is evident in the main portion of the beach as represented by Section 2, but is absent from the eastern and western extents of the beach (Sections 2 and 3). The steep submarine slope forms the southern side of the tidal channel, the orientation of which, is shown clearly by the darker blue water adjacent to the central part of the Peninsula in Figures 1.1 and 1.2.

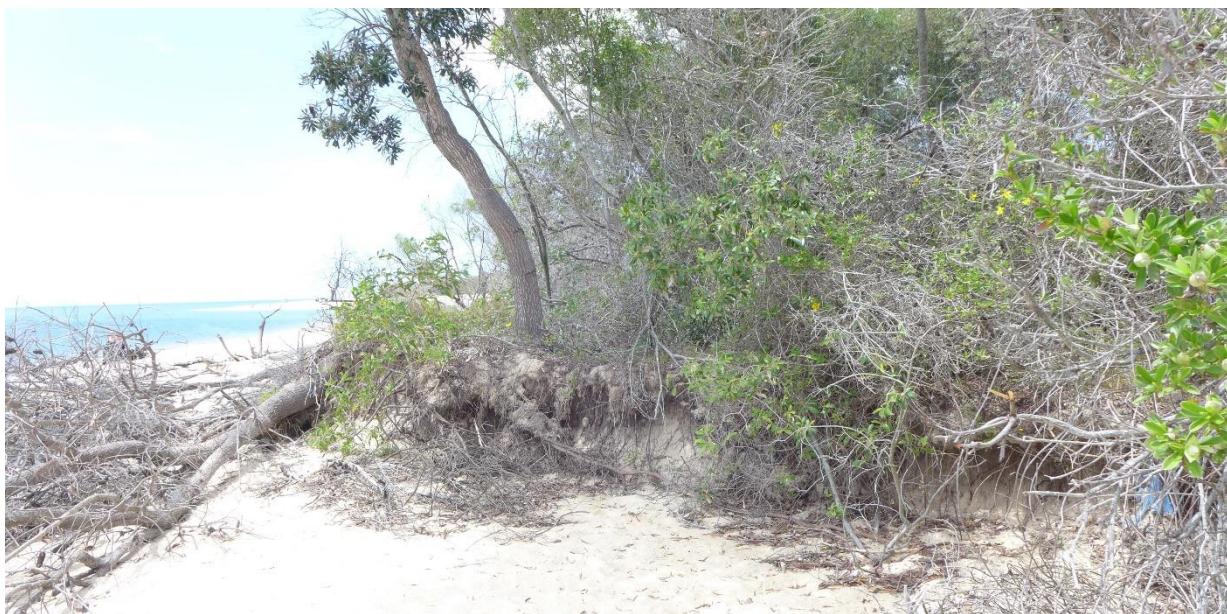
Figure 2.1 A small scarp at the rear of the vegetation line which is interpreted as the rear ward extent of past instability

Within some of the broader scallops in the vegetation at the back of the beach, scarps are evident within the sand up to about 0.7m high, coinciding with zones of fallen trees (Figure 2.1). As these scarps are evident at elevations above the usual high water level of about 2m, we interpret them as the back scarps of previous instability events rather than the consequence of storm surge, as they are arc shaped and do not extend over the entire back beach area. In subsequent sections we present correlation with observed scarps and the locations of past instability events.

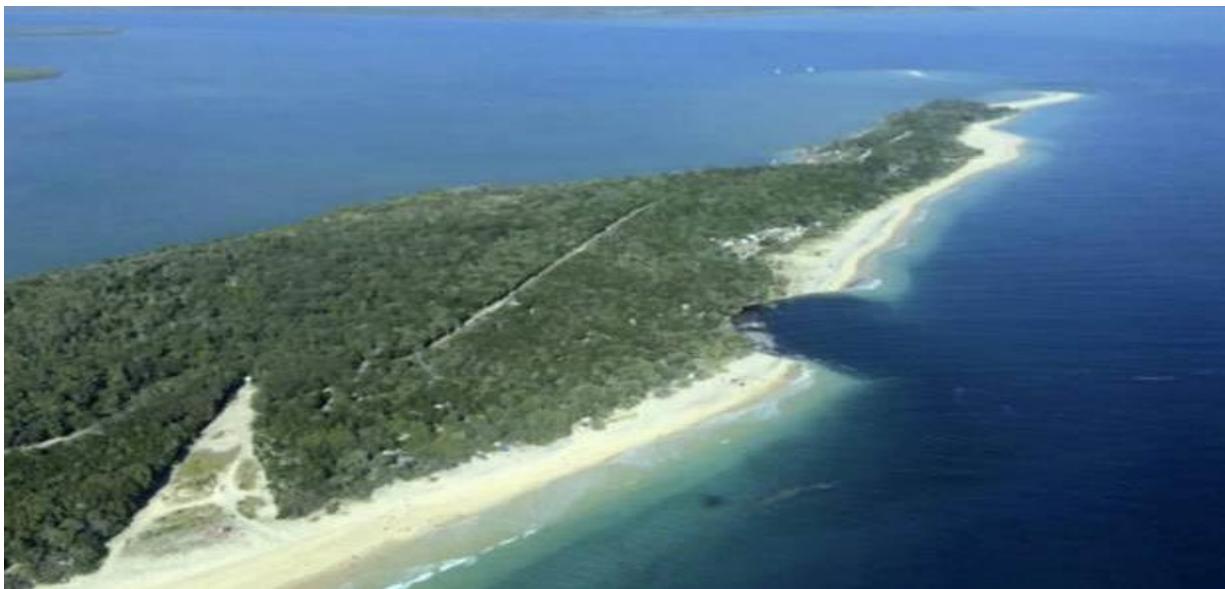
Figure 2.2 Oblique aerial image of the 26 September 2015 instability event. Image source: ABC.Net.Au

- The back scarp of the zone of instability had regressed only 2 m to 3 m metres from the position observed on Saturday evening and been reduced in slope in some parts to form a beach.
- Rapid and turbulent tidal flows and eddies were evident along the edge of the channel, where the adjacent beach falls to the sea floor.

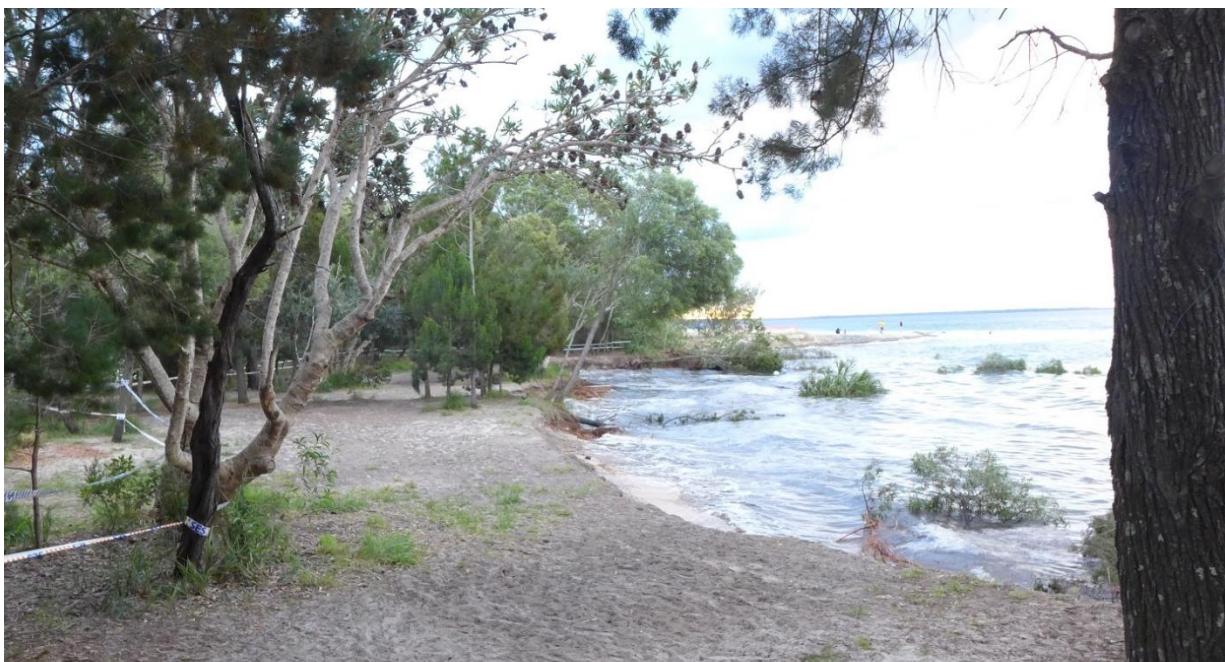
Figure 2.3 View across the rear of the instability event looking west on the afternoon of 27 September 2013

During the visit on the morning of 28 September 2015 we were informed by staff on a Coast Guard vessel that the depth of water in the instability zone was a maximum of 9 m, shelving back to about 7 m closer to the beach.

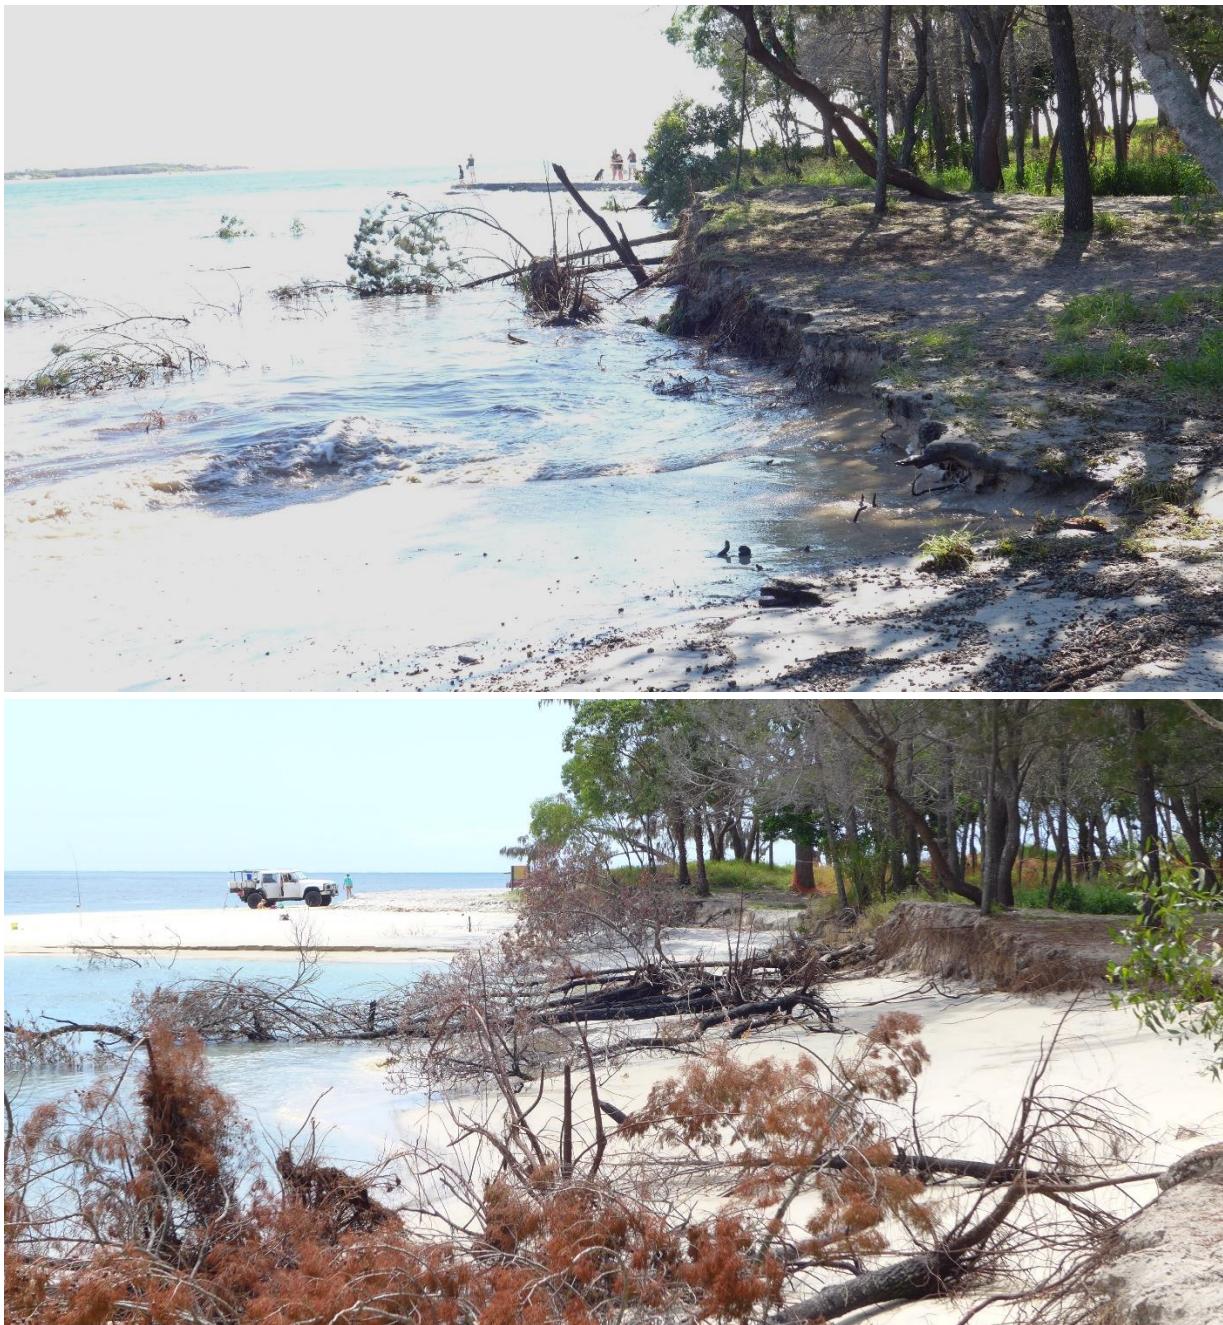
Figure 2.4 Similar view from 26 September 2015 at around high tide (top) and 26 October 2015 at about low tide (bottom) illustrating several metres of further regression of the back scarp.

In our follow up visit on 26 October 2015 to assess surface conditions along the whole peninsula we observed regression of the back scarp of about 3 m and some broadening of the beach below the scarp as shown on Figure 2.4.

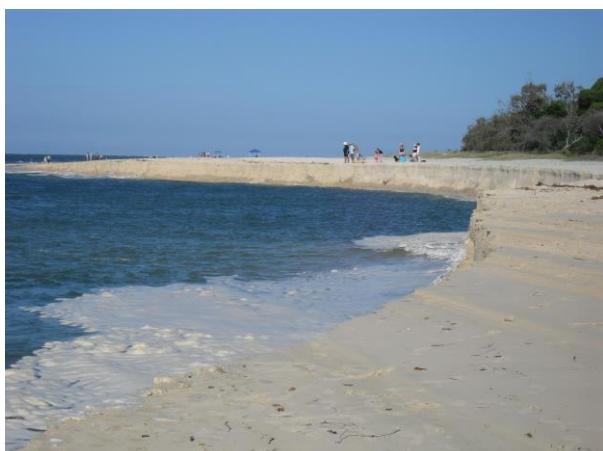
a. 2010-1

Figure 3.1 Photographs showing the head scarp of four separate instability events at Inskip Point either within the early stages of retrogression (a,b) or a within day following (c,d)

The photographs demonstrate that the general surface expression of the various events is similar, with the head scarp forming an arc shaped near vertical face which retrogresses up the beach. Once retrogression is complete, a beach forms below the scarp and increases in width on the fall of the tide following.

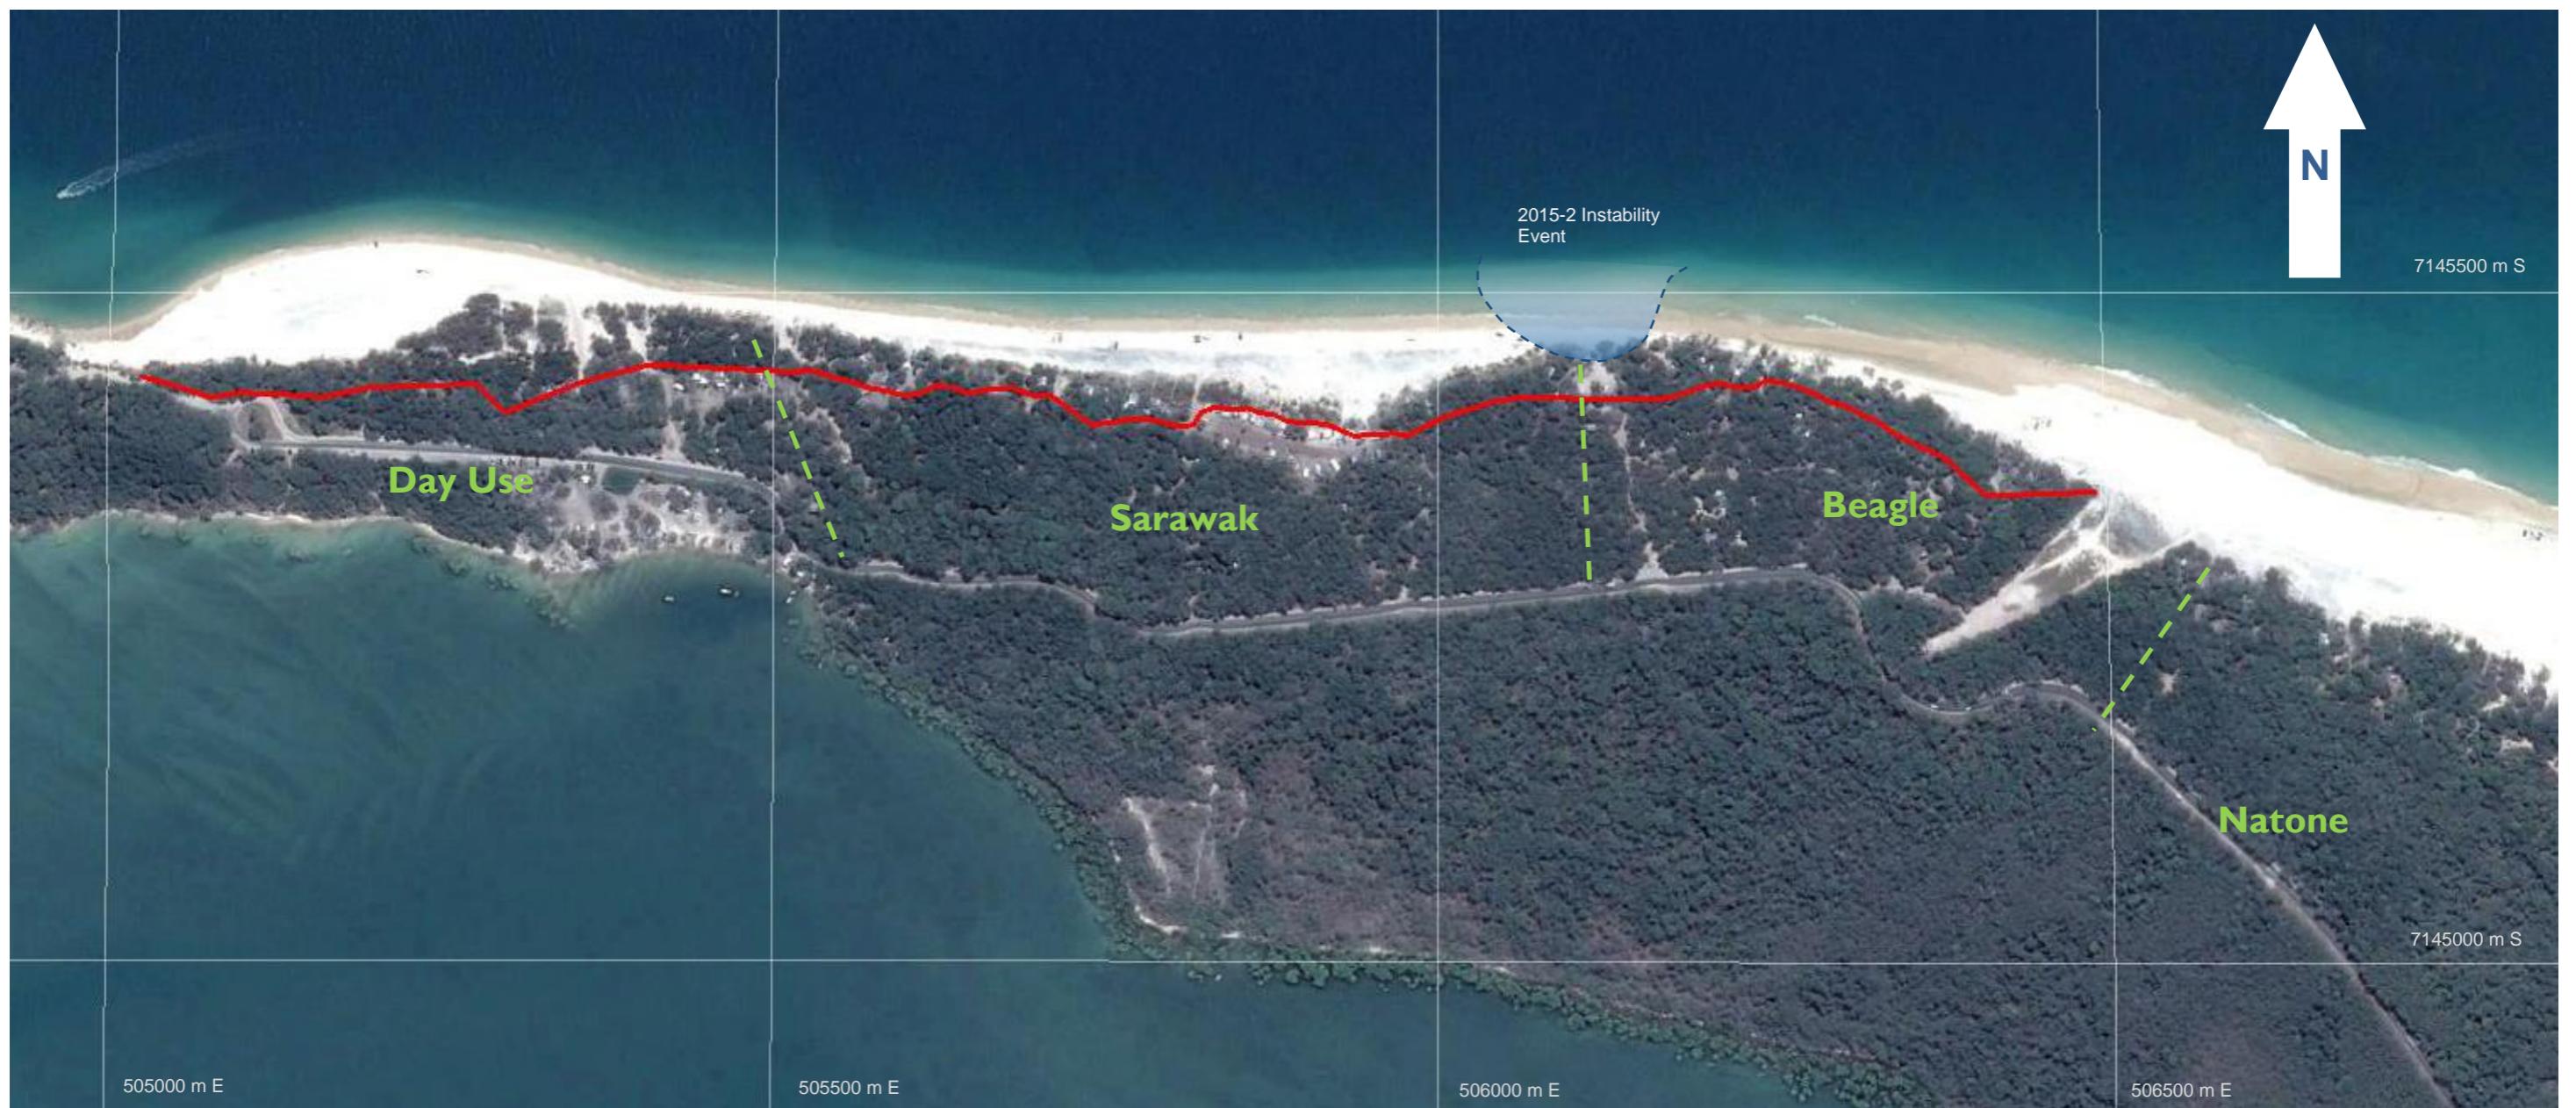
Proposed seaward boundary to camping buffer zone

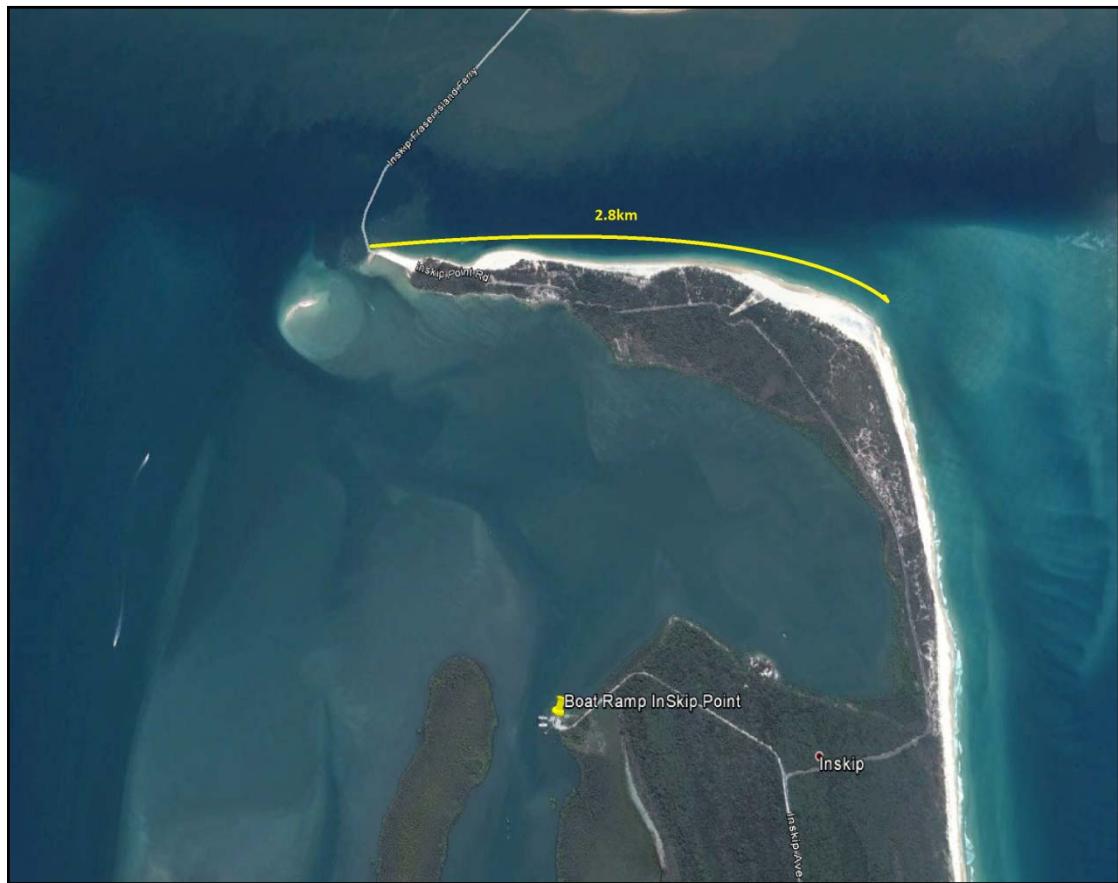
(Image No.2) Extract of Inskip Point from Google Earth

Image No.2 shows the approximate survey area (yellow line) which is approximately 2.8km along the point's beach line. The site is approximately 3 km from the Inskip boat ramp, which is to south of the site on the inner side of the spit.

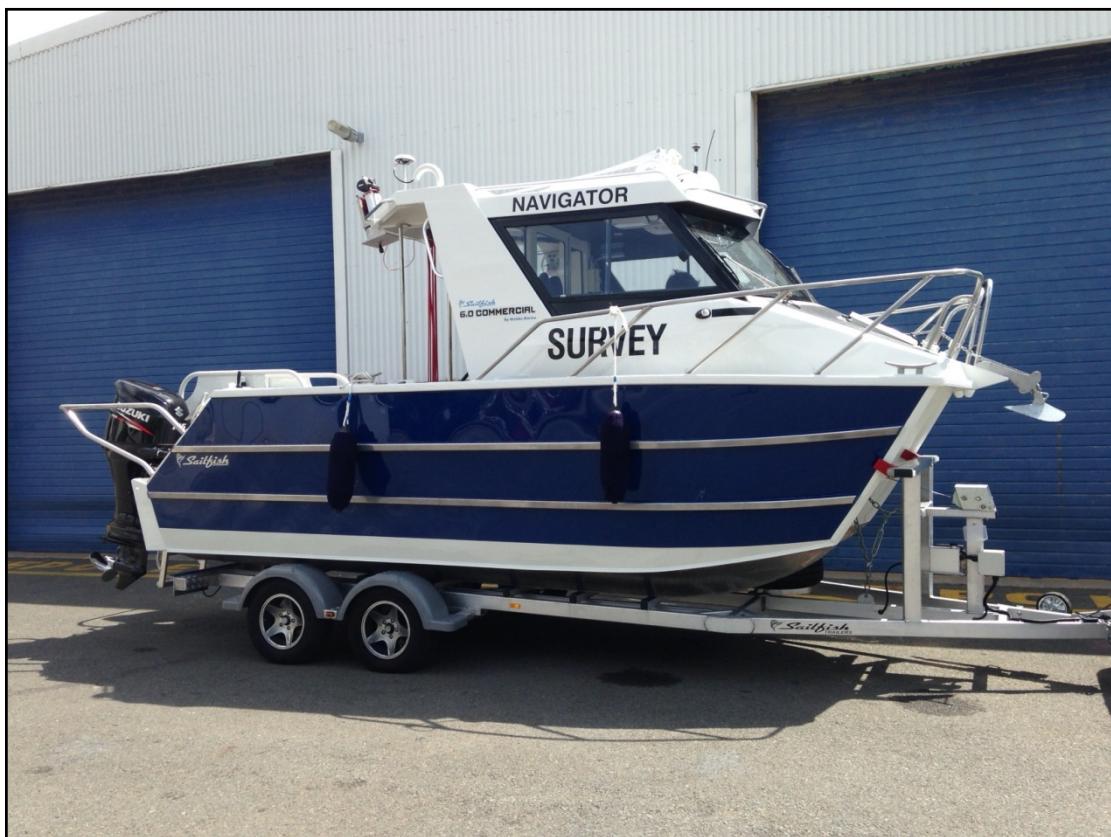
(Image No.3) PBPL 7m Survey Vessel “The Navigator”

The “Navigator” (7m) was the vessel used to undertake hydrographic survey work. It is fitted out with a RESON 8125 Hybrid shallow water multibeam system and an Applanix POSMV motion sensor.

The multibeam sonar head is mounted in a purpose built moon pool and is permanently tilted at an angle of 15° towards starboard. The RESON 8125 Hybrid system is capable of horizontally steering the sonar ping electronically, enabling the surveyor to choose in real-time whether they want to survey directly below the vessel or to the side. The location of the moon pool is close to the centre of gravity of the vessel to enable maximum stability and accuracy of acoustic data collected. The precise positioning of all soundings is achieved by using an Applanix POSMV motion sensor system.

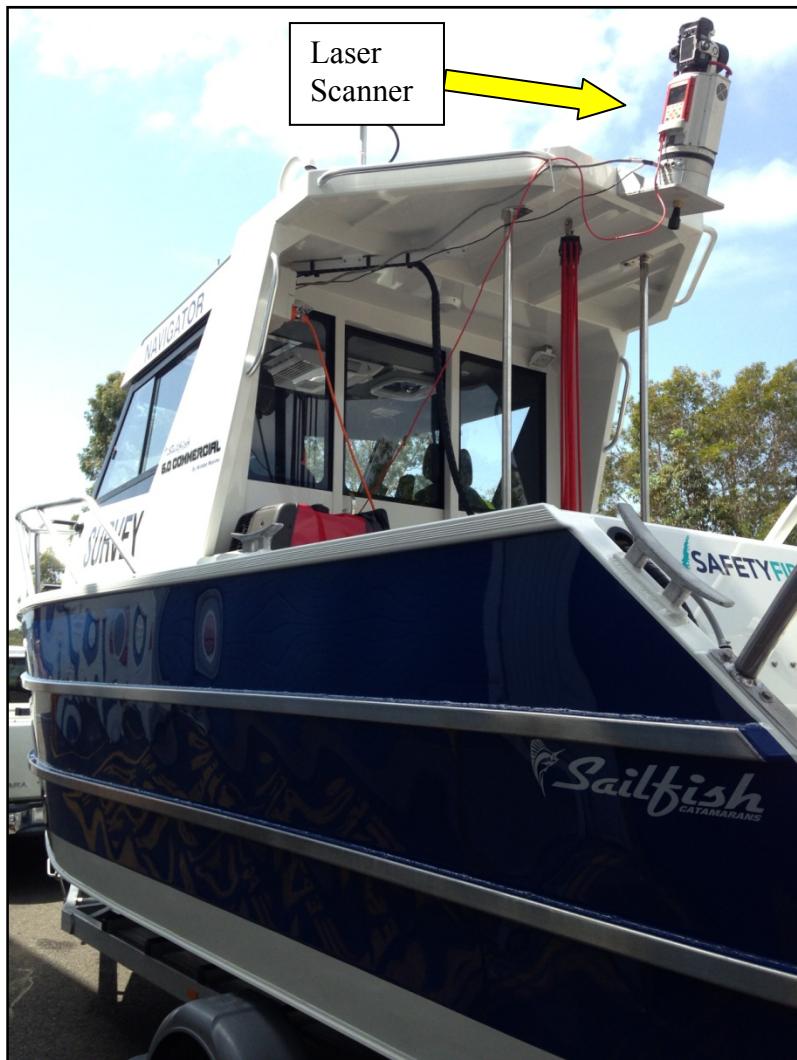
(Image No.4) Laser mount configuration on the ‘Navigator’

A Riegl VZ-2000 Laser Scanner was mounted to the roof of the Navigator at a 15° pitch to help pick up circular vertical objects like light posts and beacons. The VZ-2000 contains a Class 1 Laser with a maximum measurement range of up to 2000m. The laser has a measurement rate of up to 230,000 measurements per second at a range of 750m with a 100° Field of View. This provided an extremely high detail dataset of the Inskip coastline within the survey area.
